SAFETY ALERT

Incorrect trailer operations

"Sharing incident learnings across the grain industry"

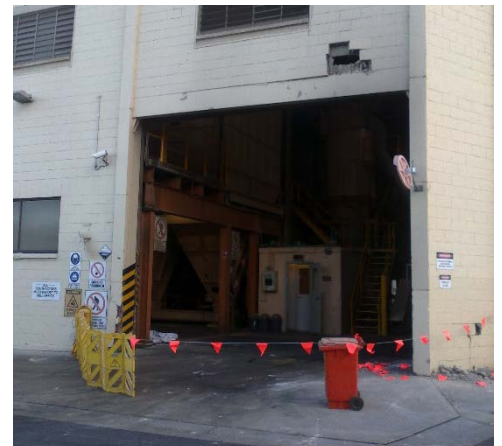
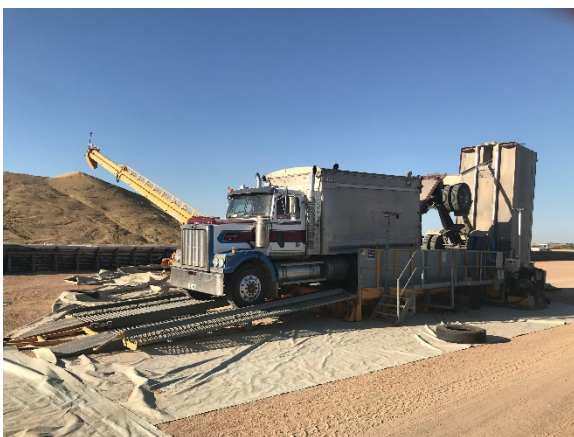
There have been recent incidents at grain sites where drivers have not lowered their trailers prior to driving away, resulting in the trailer colliding with grid doors, grid roofs and height warning indicators.

There have also been instances where incorrect trailer operations have resulted in trailers tipping and ended up standing vertically due to tailgates not being opened correctly.

- Make sure your trailers are lowered prior to placing your truck in motion.
- If you see a moving vehicle with a trailer raised, warn others, and report it to site employees immediately.
- Drivers must be aware of their vehicle height.
- Observe and obey all height warning signs. If in doubt always measure truck height prior to entering a height restricted area such as an enclosed grid.

- Ensure the correct trailer is being elevated when discharging your load.
- Ensure your tailgate is opened prior to commencing discharge.
- Ensure appropriate chains are installed on all tailgates.
- Follow the direction of site employees during discharge.
- Ensure your brakes are applied when exiting the truck.
